Ultrasonic Inspection of the LTAB Floor

Graham Thomas

July 31, 2001

Lawrence
Livermore
National
Laboratory

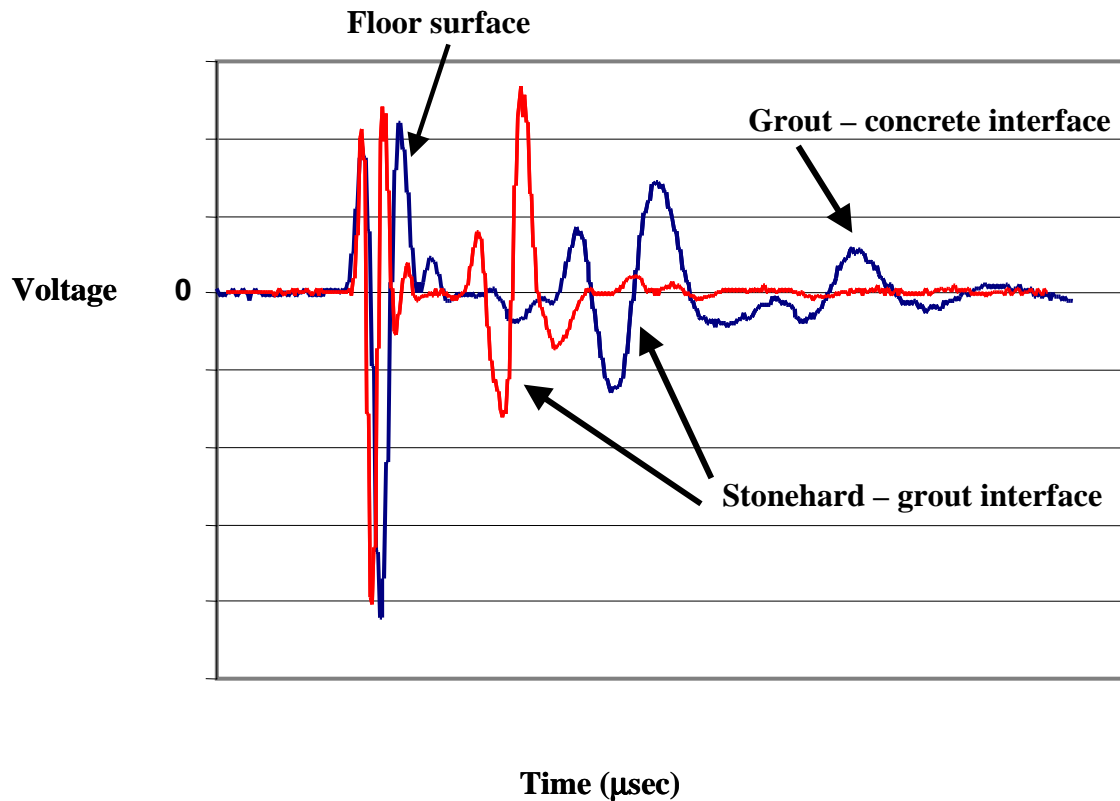
Figure 3. Typical ultrasonic responses from damaged (red) and undamaged (blue) sections of the NIF floor. Note the absence of the grout to concrete signal in the damaged floor signal. Also note the change in amplitude and location of the Stonhard-to-grout signal. The shorter time between the floor surface signal and the Stonhard-to-grout interface signal denotes a thinning of the Stonhard coating. The increase in amplitude indicates that there is more air at the interface in the damaged (red) signal.

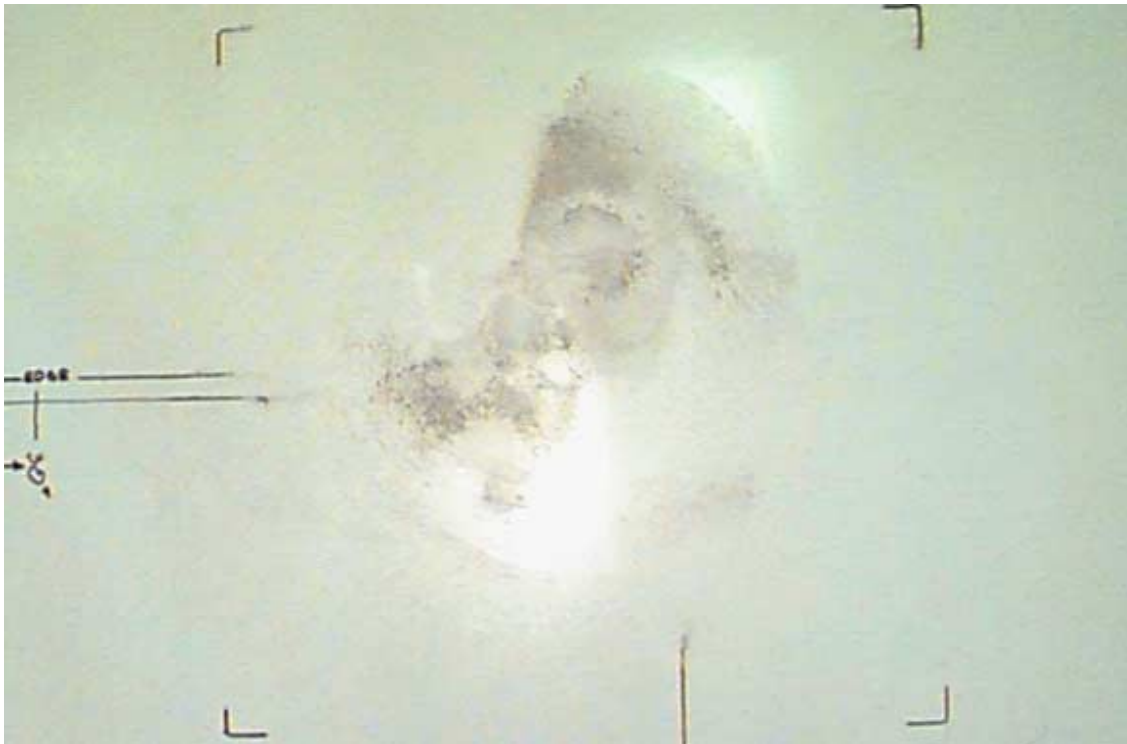
The first experiment was designed to determine the floor's response to turning the wheels in the same location. The transporter wheels were rotated 90 degrees and back 90 degrees this constitutes one 'turn') and the transporter was moved laterally off the area to allow access to the floor. We ultrasonically evaluated the floor after each rotation of the wheels for a total of 16 turns. Each time we cleaned the floor after the ultrasonic measurement was performed. We did not sense any degradation to the grout layer on the side where the floor was cleaned during this experiment. The surface of the floor showed minor wear after 12 rotations, see Fig. 4. The other wheel area was not cleaned and the floor experienced significant damage, see Fig. 5. Note that the damage in the area that was not cleaned showed obvious evidence of sub-surface delamination: a bubble appeared and a hollow sound was made when the floor was tapped.

Figure 4. Floor surface after 12 rotations with the floor cleaned after each rotation.

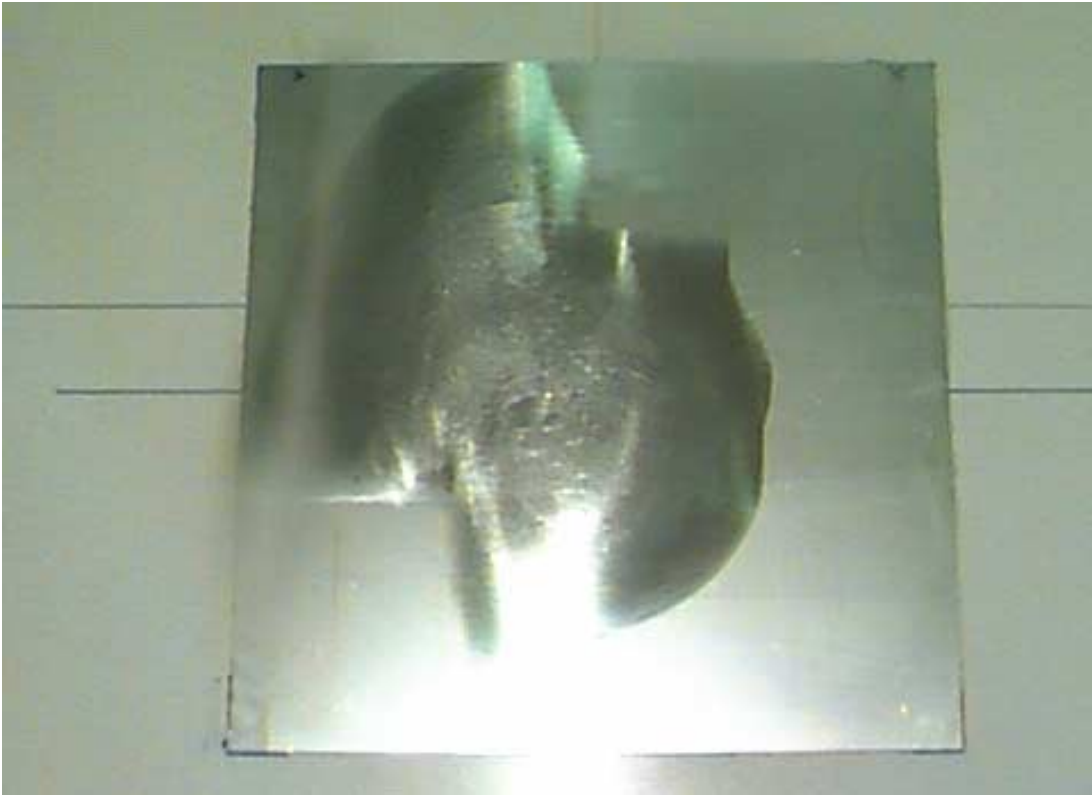
Figure 6. Photograph of steel plate after transporter wheel pivoted 50 times in place.

A potential solution to the rotating wheel damage is to place a thin steel plate on the floor where the wheel pivots. We conducted a second experiment where thin steel plates were attached to the floor with double-backed tape at the location of the wheel-turning, see Fig. 6. Ultrasonic evaluations were conducted at intervals up to a total of one hundred turns and no damage was detected in the grout layer.

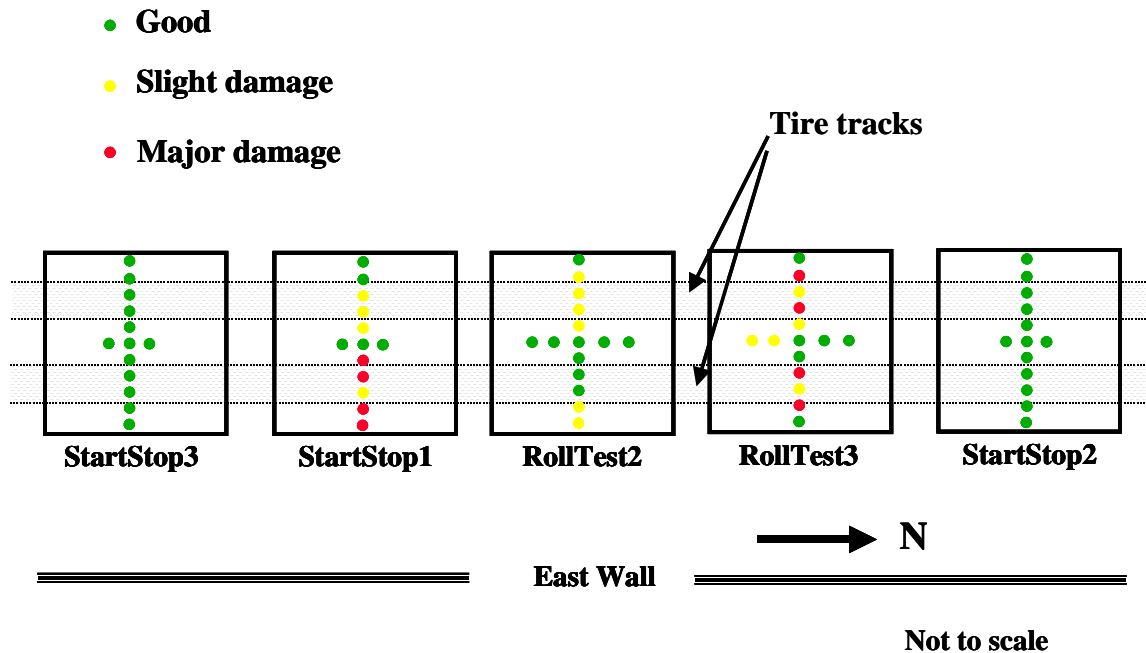
An experiment was conducted to determine the susceptibility of the floor to damage as the transporter moved across the floor. A test sequence was established to measure the ultrasonic signals after up to 1000 passes over the same location on the floor. Appendix A details the experimental sequence. We monitored the start-stop location as well as two locations along the path. A grid template was placed at the locations shown in Fig. 7 and described in Appendix B. We detected damage in the grout layer in isolated areas in a little as 32 passes. There were distinct ultrasonic indications of grout damage in several areas after 500 passes. Figures 7 and 8 graphically depict the ultrasonic measurement sites and the qualitative damage assessment. The next measurement interval was to be at 1000 passes. The floor failed catastrophically at around 900 passes. Figure 8 depicts the ultrasonic evaluation at the same locations as well as at locations under the other wheels. We ultrasonically evaluated the other wheel's track and could sense the deterioration of the grout layer. Figure 8 shows that most of the subsurface damage occurs under the loaded

Figure 7. Results of the ultrasonic damage assessment after **500** traverses of the transporter. Note location of sub-surface damage relative to tire tracks.

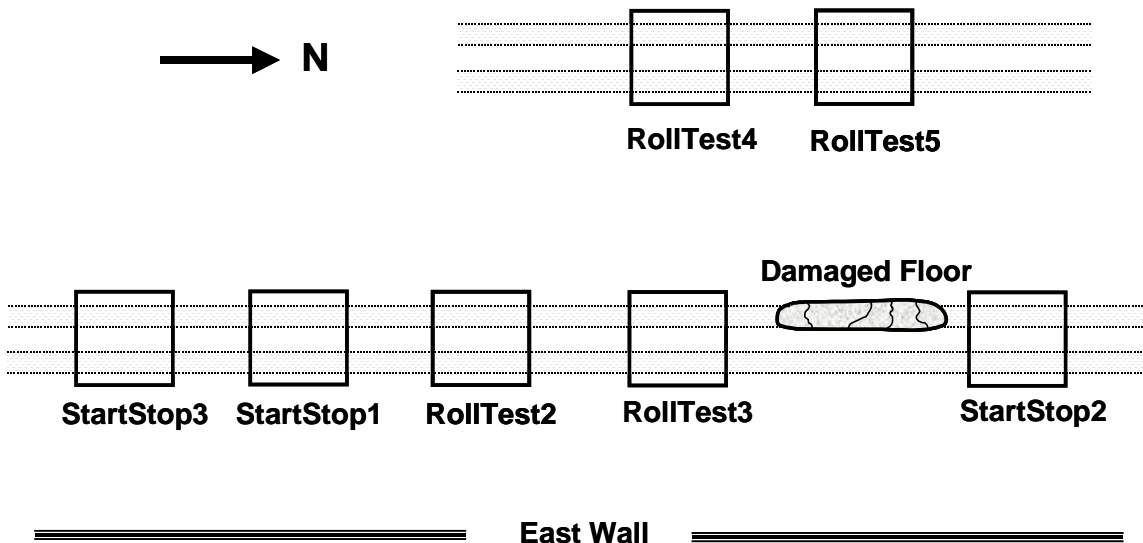
wheels and little damage occurs between the wheels. Figure 9 is a map of the locations that ultrasonic data were acquired. Figure 10 is a photograph of the damaged floor.

Figure 8. Results of the ultrasonic damage assessment after **900** traverses of the transporter. Note location of sub-surface damage relative to wheel tracks.

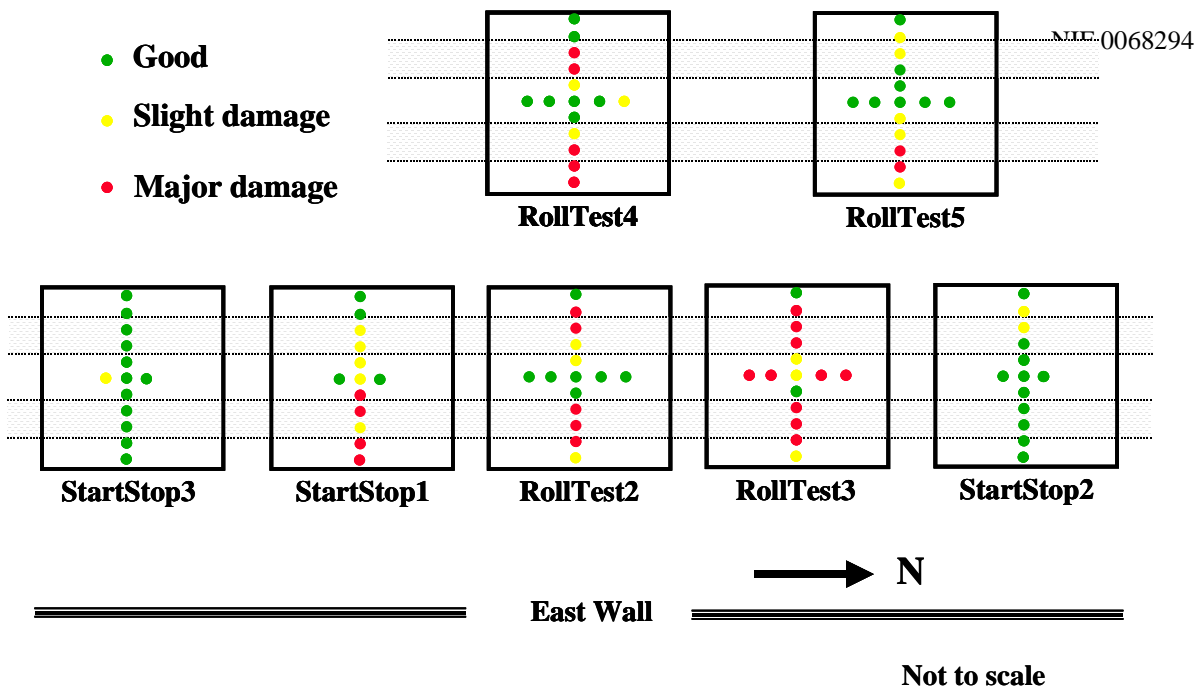
Figure 9. Map of ultrasonic data acquisition locations. Front wheel stopped at StartStop3 and rear wheel stopped at StartStop1. Note location of visible floor damage. RollTest4 and RollTest5 areas are where the other set of wheels traversed and was evaluated only after 900 traverses. No visible damage was noted under these wheels.

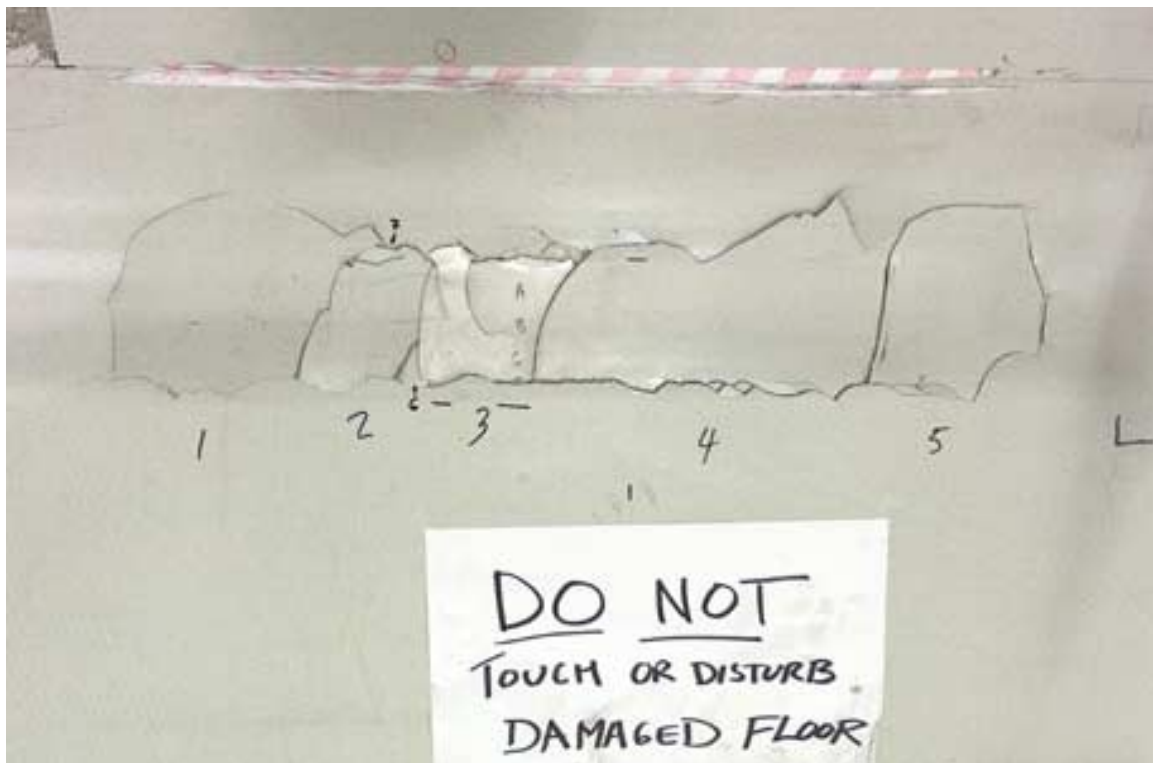
Figure 10. Photograph of the damaged floor caused by the transporter traversing the same track 900 times.

1. Ultrasonic evaluation detects the onset of damage in the grout layer caused by loading from the transporter. To quantify the ultrasonic measurements we need to capture ultrasonic data during a controlled destructive test of a floor section.
2. For a fully loaded transporter, turning the casters in place produces sub-surface damage in as few as 12 turns depending on how clean the floor and the tires are.
3. Rolling loading will damage the floor in as few as 32 traverses and catastrophic failure may occur at approximately 1000 passes.

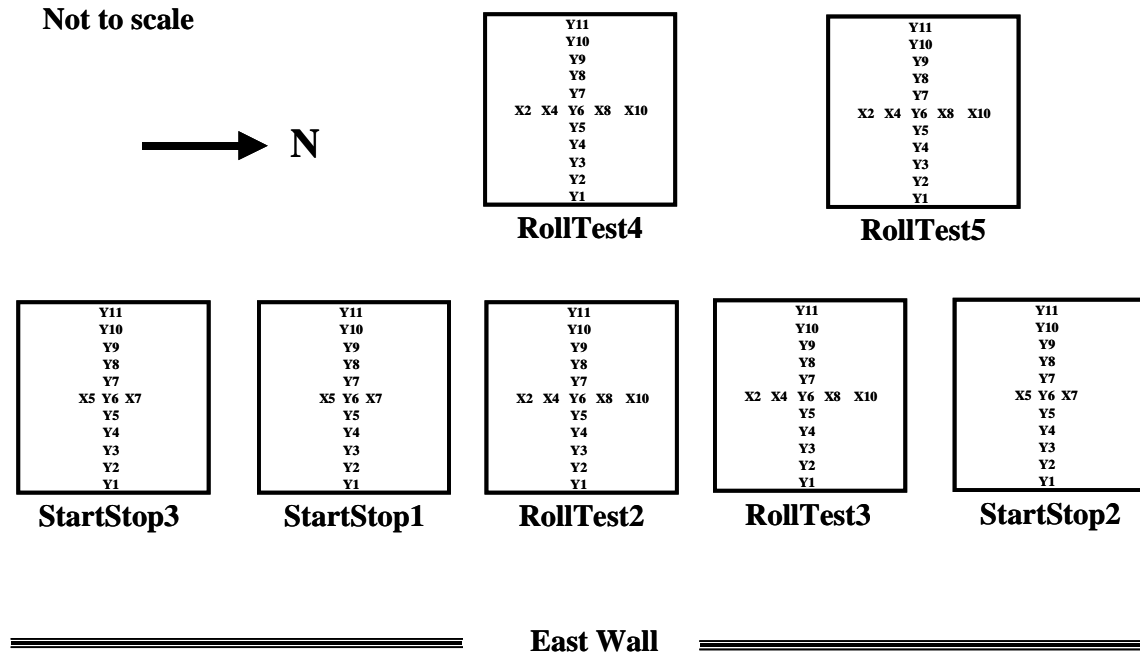
Figure AB1. Diagram of ultrasonic data acquisition locations for traversal test. The floor sustained failure at a location between RollTest3 and StartStop2. Note that these locations are not to scale.

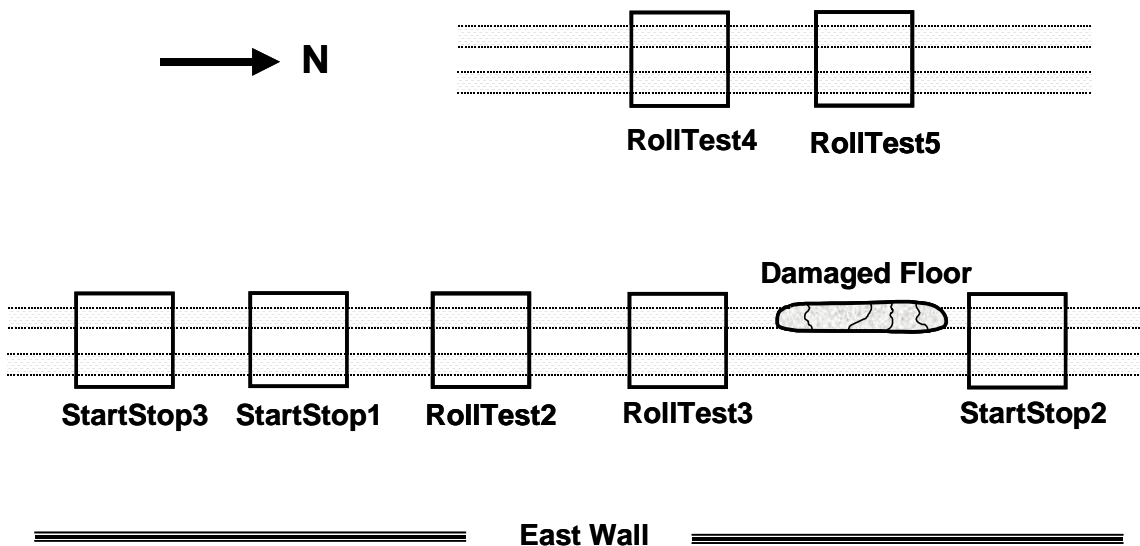
Figure AB 2. Locations of ultrasonic data acquisition relative to damaged area. This drawing is somewhat to scale.
